TECHNICAL BULLETIN No. 46 DATE: 3/1/01

SUBJECT: CDP-1100 & CDP-4100 Not Charging

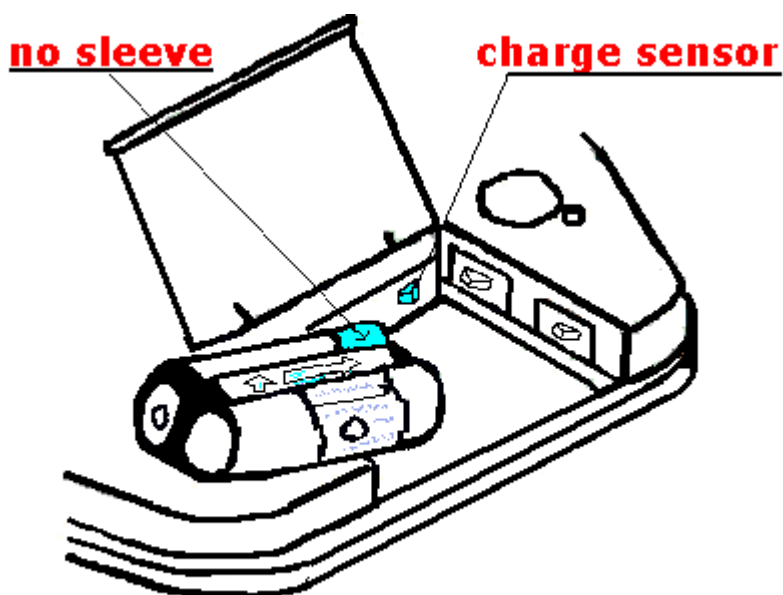
Fault: Customer's report that the supplied nickel cadmium battery model number NBP-50A does not charge.

Cause: Despite, a good description, in the Instruction Manual and arrow markings on the battery, the customer inserts the battery upside down. While the polarity is correct, the Charge-sensor terminal does not make contact with the battery body, which disables the charging circuitry.

Remedy: Insert the battery, so that one of the Arrows points toward the Headphone socket and other toward the Lid of the battery compartment. Make sure that the metal body of the battery is in contact with the charge-sensor terminal. See the diagram below.
