CONSUMER ELECTRONICS DIVISION

TECHNICAL BULLETIN No. 62

SUBJECT: CP21AF1V

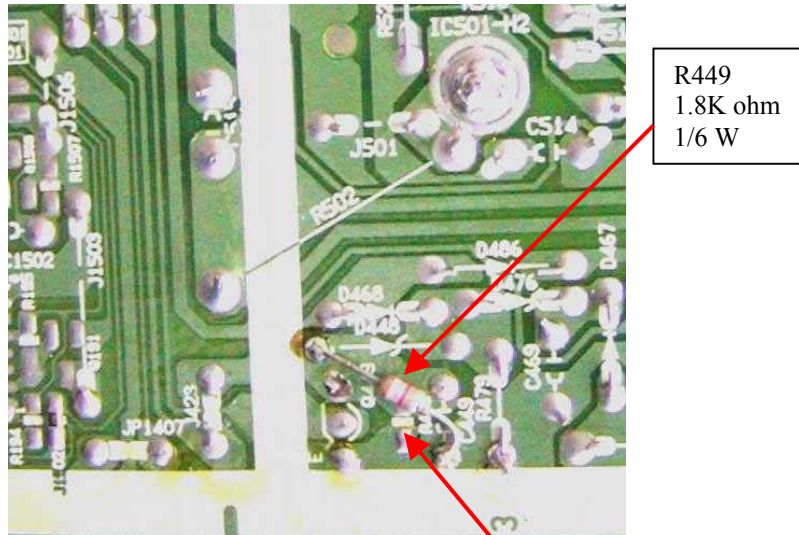
Fault: Switches to “Stand by” intermittently.

Cause: Loss of synchronisation between “Hold-down” and “Stand-by” circuit.

Remedy: Replace R449 10K ohm surface mount resistor to 1.8K ohm.

Method: If surface mount resistor is not available, a 1.8K ohm 1/6W resistor can be used. See Fig. 1 Below.

Remove R449 10K
Surface Mount
