SANYO Australia Pty Ltd

TECHNICAL BULLETIN No. 63

DATE: 15/12/03

SUBJECT: CP21SA1

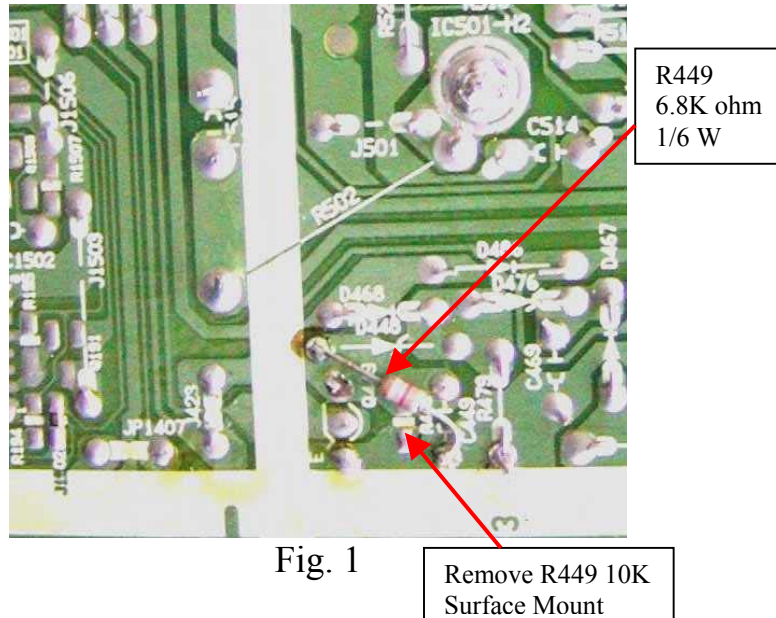
Fault: Switches to “Stand by” intermittently.

Cause: Loss of synchronisation between “Hold-down” and “Stand-by” circuit.

Remedy: Replace R449 10K ohm surface mount resistor to 6.8K ohm.

Method: If surface mount resistor is not available, a 6.8K ohm 1/6W resistor can be used. See Fig. 1 Below.
