SANYO Australia Pty Ltd

TECHNICAL BULLETIN No. 67

DATE: 03/08/04

SUBJECT: CP20SR1(G)/CP21SA1(G) 50Hz Buzz

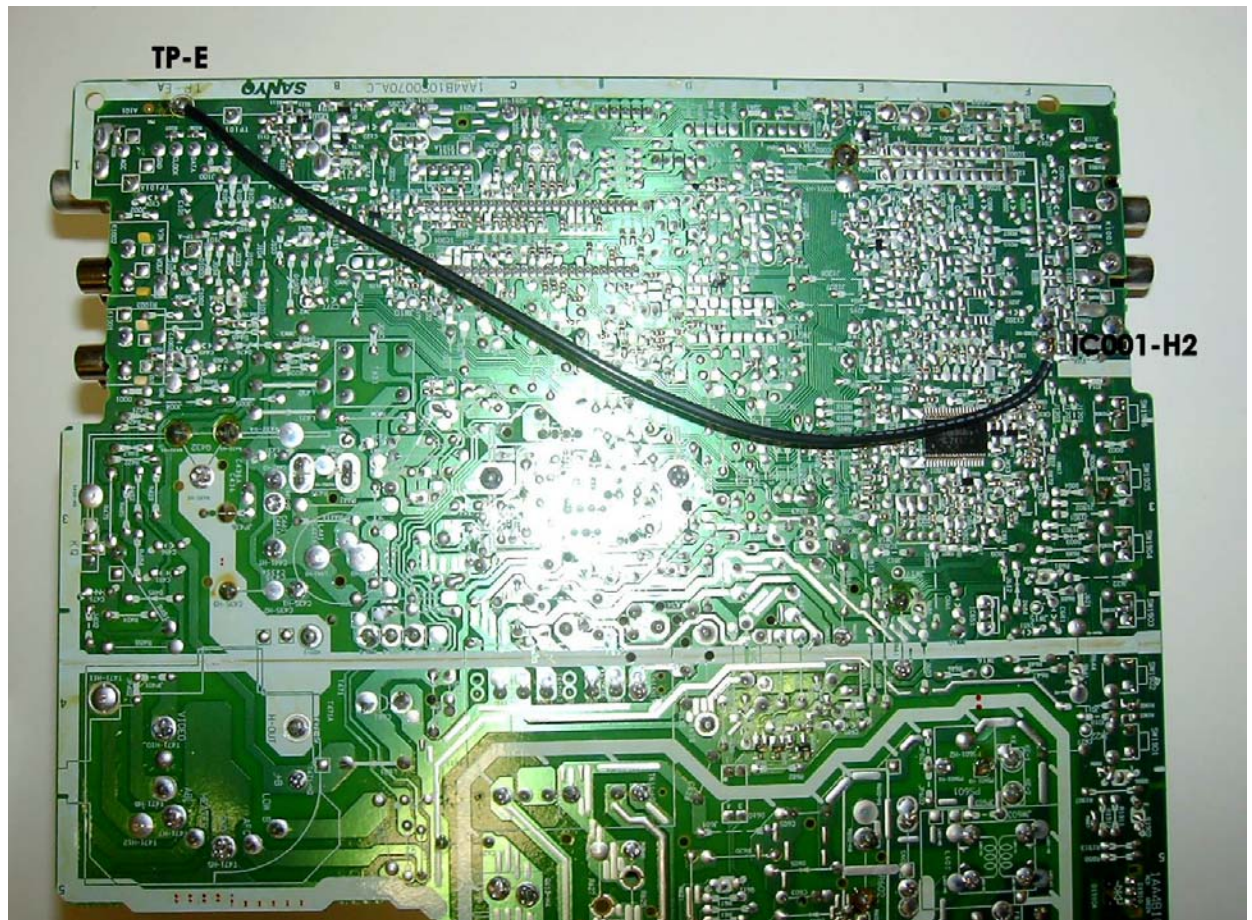
Fault: 50Hz audio buzz from speakers.

Cause: Earth loop.

Remedy: Connect a heavy gauge wire between “TP-E” (near tuner) and “IC001-H2” (behind front AV inputs).

Method: See picture below.
