TECHNICAL BULLETIN No. 81 DATE: 10/09/09

SUBJECT: EMC7586V Under Cooking in Convection Mode

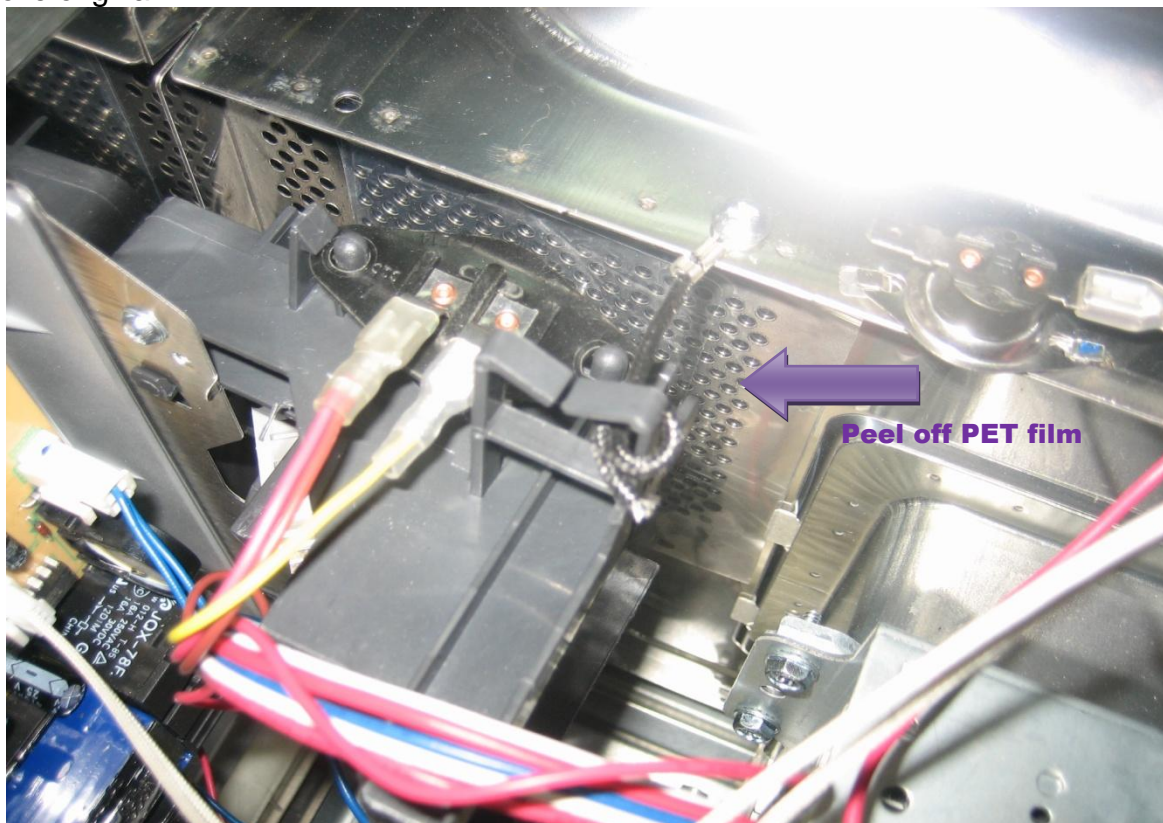
Temperature sensor PN: MM51401000008 is not the correct type and too much ventilation of oven cavity.

- Remove cabinet cover.
- Replace Temperature sensor.
- Remove original PET film
