**TECHNICAL BULLETIN No. 86 DATE: 23/12/10**

**SUBJECT: PDP42XR9DA Preparation for Transport**

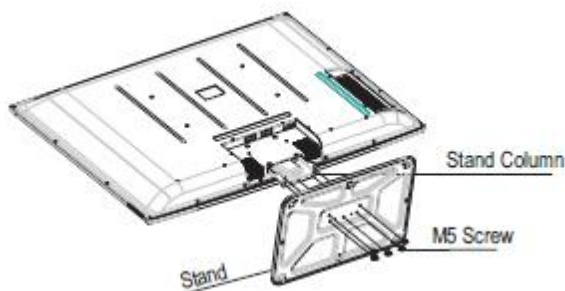
Many of this model get damaged during transport.

Impact/pressure on Stand Column cause panel to crack.

Remove the Stand Column and pack it separately, with its screws, within the carton box securely.
