TECHNICAL BULLETIN No. 72

SUBJECT: CP29AF2V(A)/CP21AF1V(A) Hum

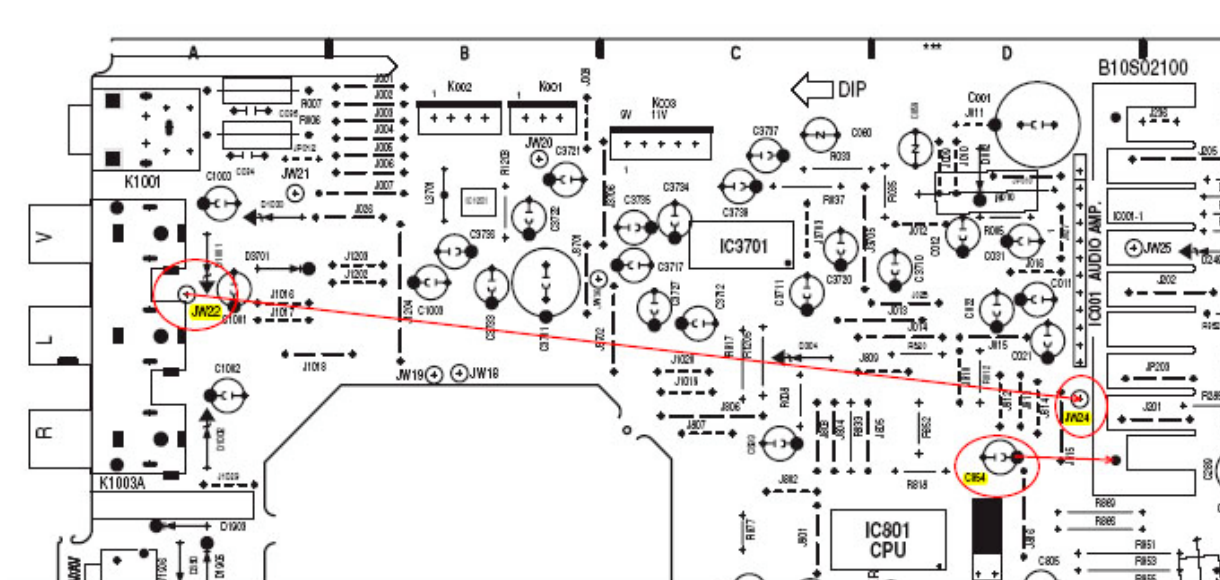
Fault: Audio buzz at low volume on high white content picture.

Cause: Earth loop.

1. Connect a heavy gauge wire between “(J)W22” (near front AV sockets) and “JW24” (near IC001).
2. Connect a heavy gauge wire between negative pin of C854 and the heat sink of IC001.
