SANYO Australia Pty Ltd

**TECHNICAL BULLETIN No. 83    DATE: 3/11/09**

**SUBJECT: LCD37XR9DA Hum at low volume**

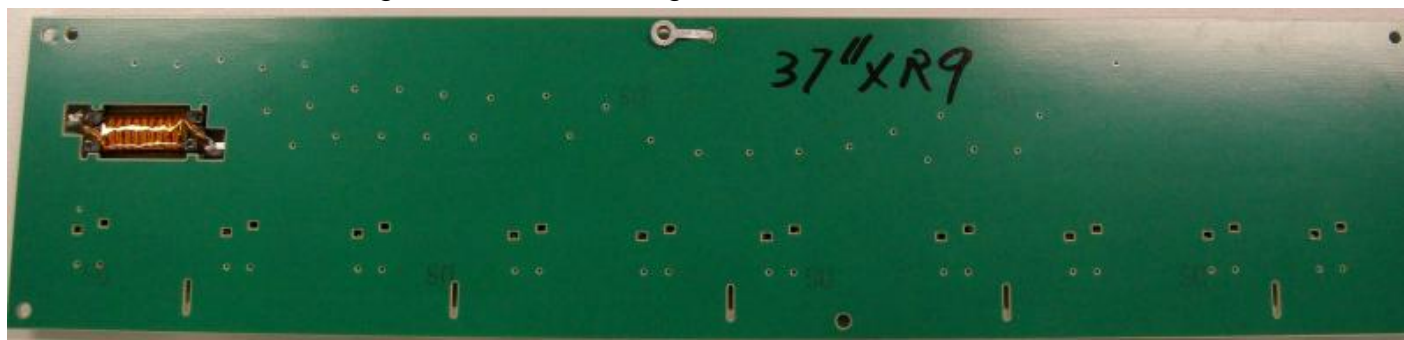
Remove the earth lug located under the right hand side middle screw hole of the Inverter PCB.

- **Temporary fix:**  
Turn off the "Light Sensor" in the "Picture" adjustment menu. (Refer to page 21 of the instruction manual.)
- **Permanent fix:**  
Remove the earth lug from the Inverter PCB.
