TECHNICAL BULLETIN No. 84 DATE: 11/03/10

SUBJECT: LCD42XR9DA Hum at low volume

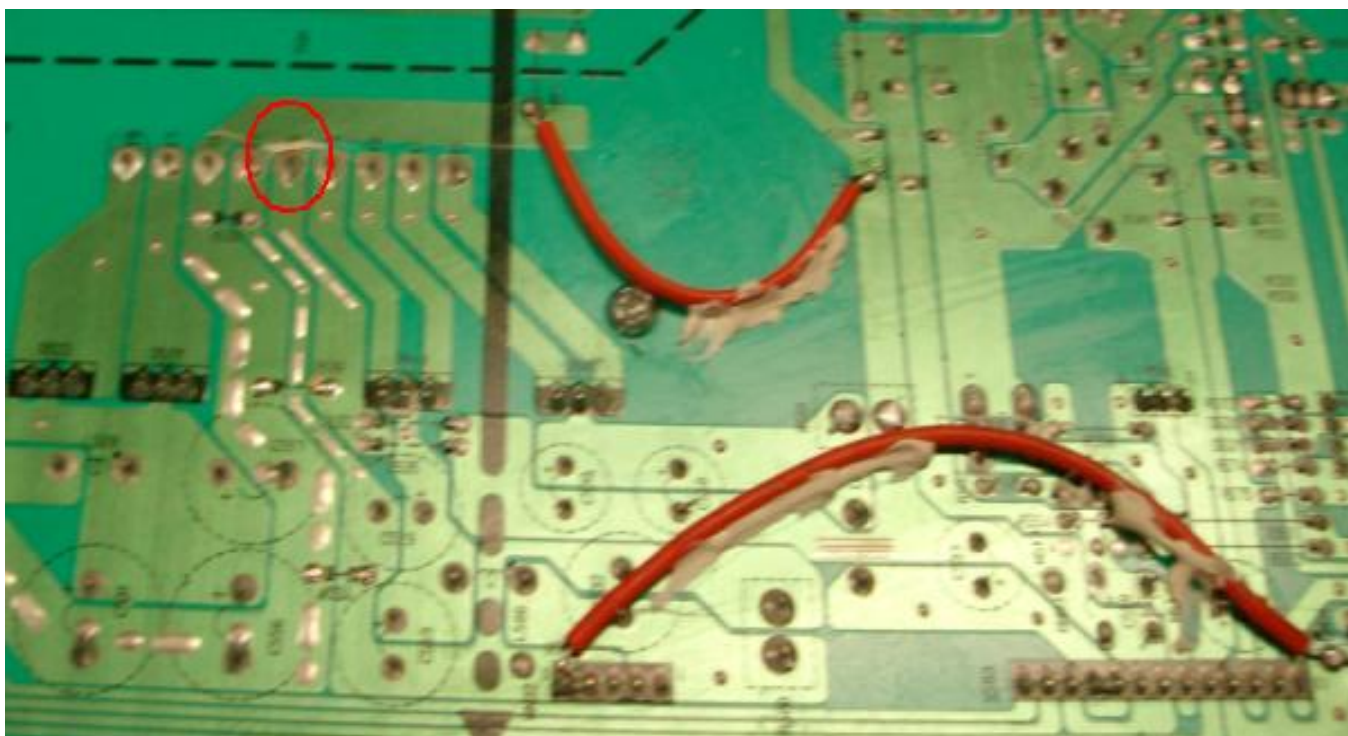
The TV emits a low hum when the "Light Sensor" is set to "On" in the "Picture" adjustment menu.

Earth-loop from the Inverter PCB causing ripple on the Audio circuit supply.

- **Temporary fix:**
Turn off the "Light Sensor" in the "Picture" adjustment menu. (Refer to page 21 of the instruction manual.)
- **Permanent fix:**
Replace Power Supply PCB. When ordering please ask for the modified one.
Or, modify the Power Supply PCB.

1. Cut earth track at pin 14 of T501. See picture below.
2. Add jumper between negative pin of C549 and secondary side of C561.
3. Add jumper between GND4 and GND2 test points.
