SANYO Australia Pty Ltd

**TECHNICAL BULLETIN No. 55A**

## **SUBJECT: CP29SV2Z 5V REGULATOR**

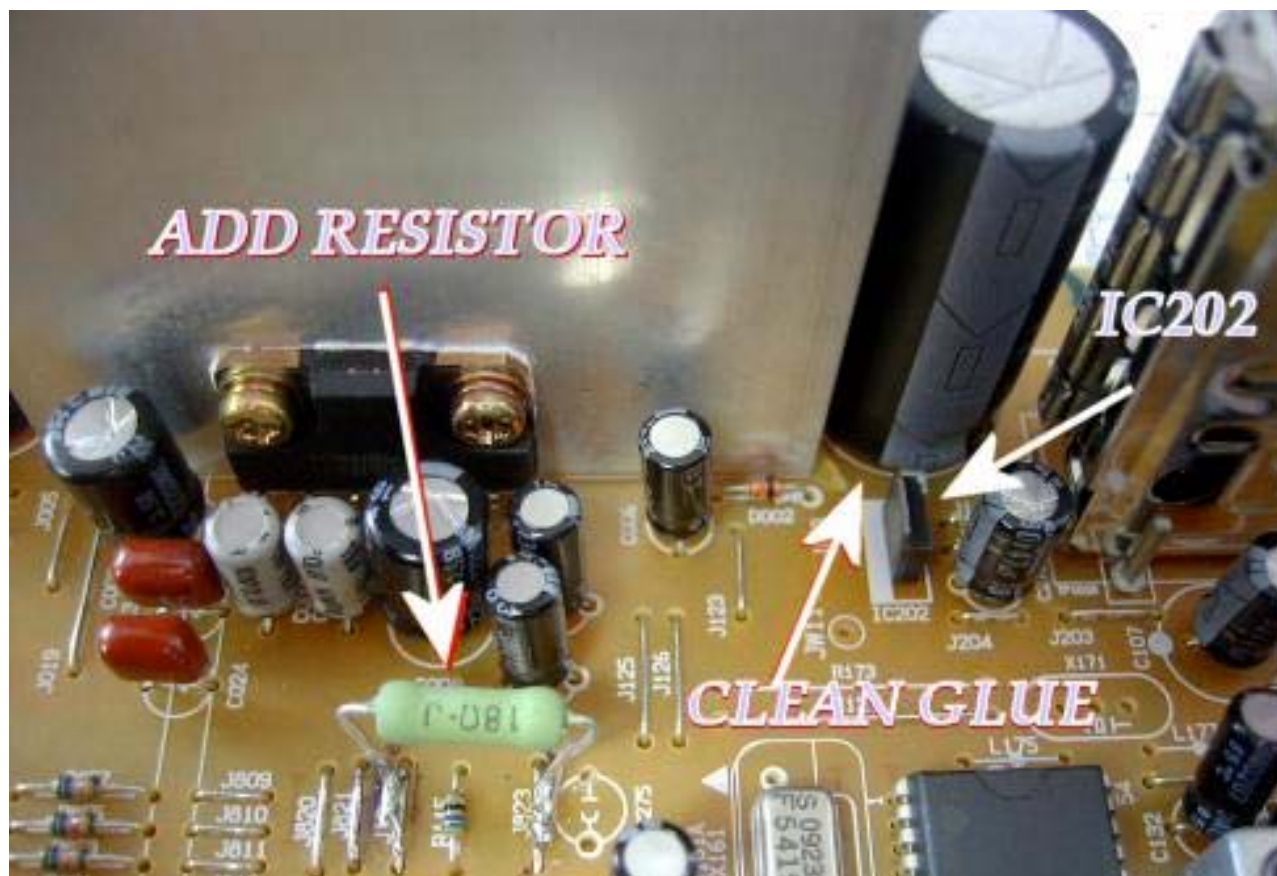
**FAULT:** Lost of colour and or vertical and horizontal instability. Some sets powers off.

**CAUSE:** IC202 (L78M05T) 5V Regulator overheating.

**REMEDY:** Replace IC202 5V regulator (78M05), clean the glue off around C013 and add an 18 Ohm 2W resistor between J124 and J823. These parts are available as a kit, part number CP29SV2ZMK

**METHOD:** Bend the resistor legs 3mm from its end to form two parallel "L" shapes. Solder one leg of the resistor to J124 and the other to J823. Refer to picture below.
