TECHNICAL BULLETIN No. 66

SUBJECT: VHR-VK310/910 High pitched mechanism noise

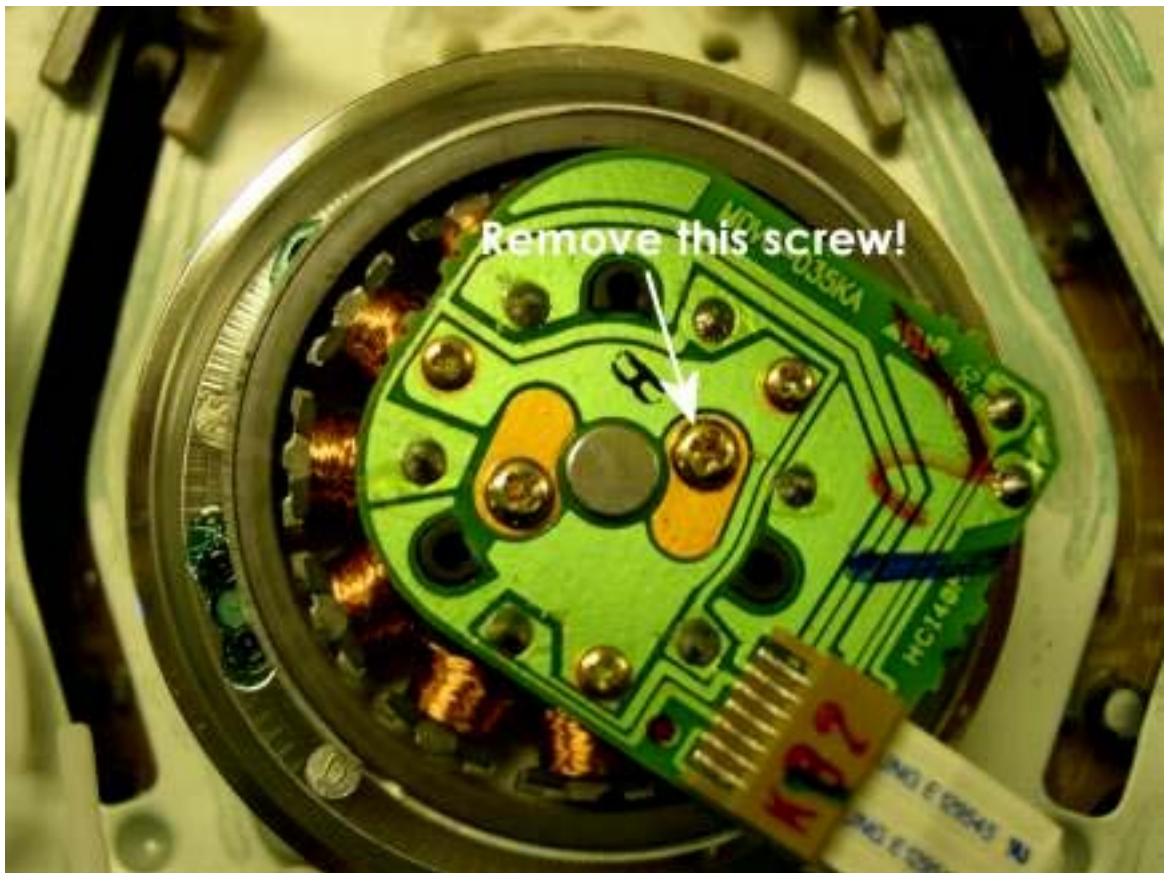
Fault: There is a high pitched noise coming from cylinder assembly when mechanism running.

Cause: Head Motor Stator warped.

Remedy: Remove one (1) screw from Head Motor Stator PCB.

Method:
