TECHNICAL BULLETIN No. 71

SUBJECT: PLC-XU50 CHASSIS 00-04

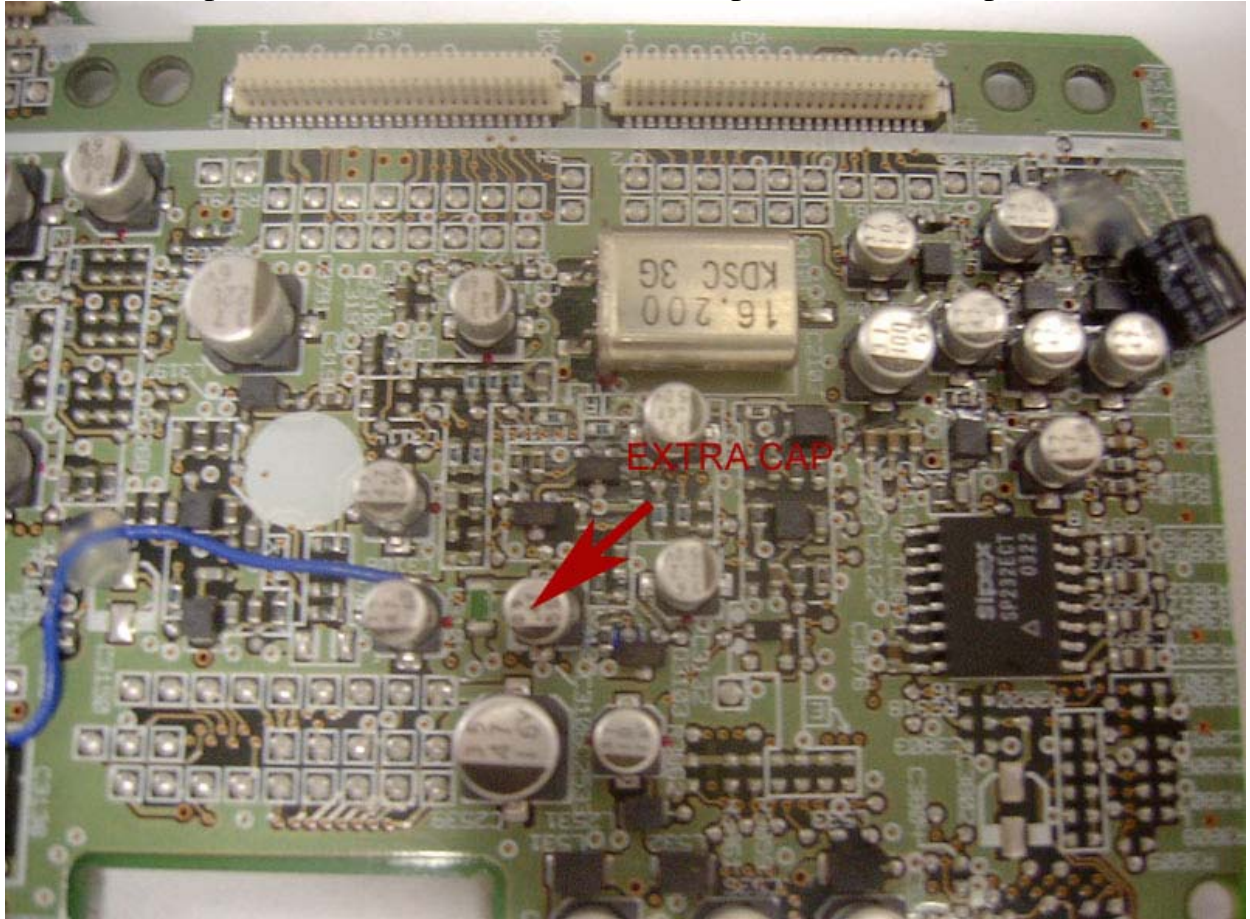
Fault: Erratic power management. First the projector intermittently switches ON, later it does not switch ON at all.

Cause: Extra (not on circuit diagram) 2.2uF 50V capacitor, on output Pin 3 of IC3201 is short circuit.

Locate the capacitor next to C3106 47uF 16V capacitor. Refer to picture below.

Replace faulty surface mount electrolytic 2.2uF 50V capacitor.
