TECHNICAL BULLETIN No. 79 DATE: 02/07/08

SUBJECT: LCD-42CA8Z “AGING TIME” DISPLAY

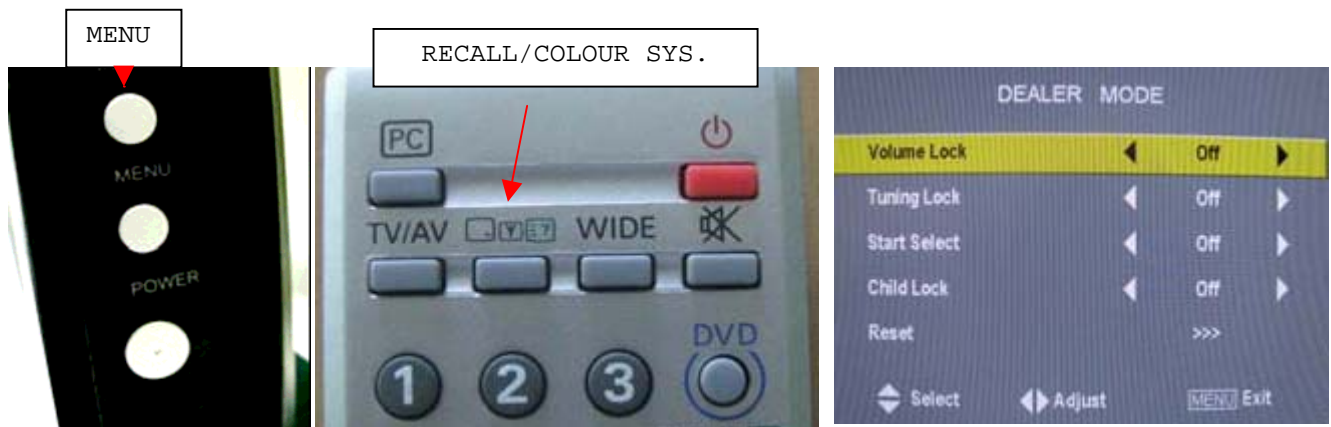
1. Power the unit on.
2. Press and hold the “MENU” button on the TV and press the “RECALL/COLOUR SYSTEM” button on the remote control. The “DEALER MODE” menu will appear.

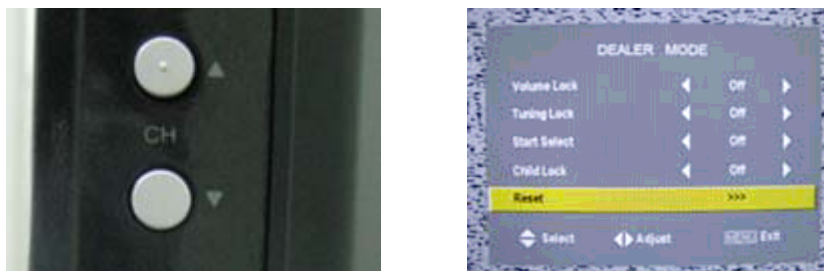
3. Use the “CH UP/DOWN” buttons on the side of the TV to select the “Reset” item.

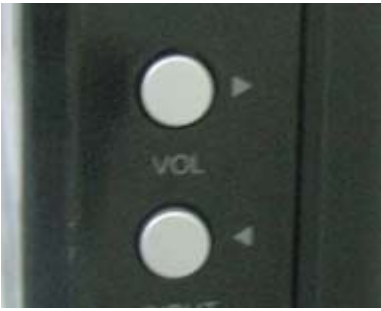
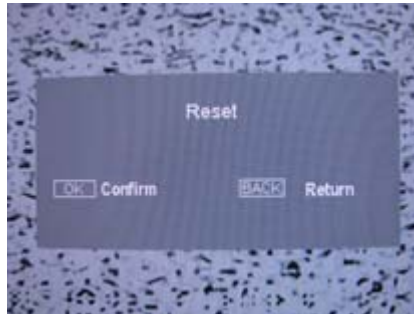
4. Press one of the “VOL” buttons on the side of the TV to start the reset.

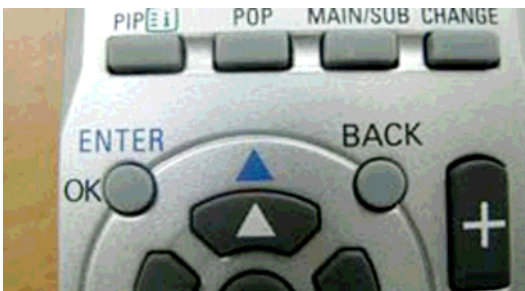
5. Press the “OK” button on the remote control to confirm the reset.
