TECHNICAL BULLETIN No. 82 DATE: 3/11/09

SUBJECT: LCD32K30TD & LCD42K30TD High pitch noise in stand-by

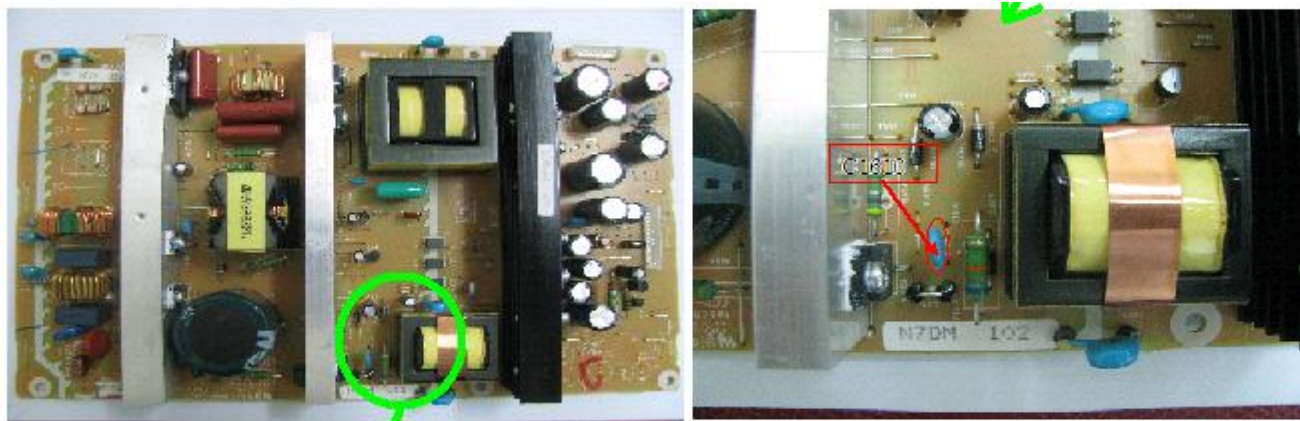
C1610 capacitor on the power supply PCB resonates.

Replace C1610 / 0.001uF 1KV capacitor with a non resonating type. Part number: 3032621809

Locate and replace C1610 capacitor on power supply PCB.
