TECHNICAL BULLETIN No. 85 DATE: 15/12/10

SUBJECT: LCD22VT10DVD Low Volume High Pitch Noise

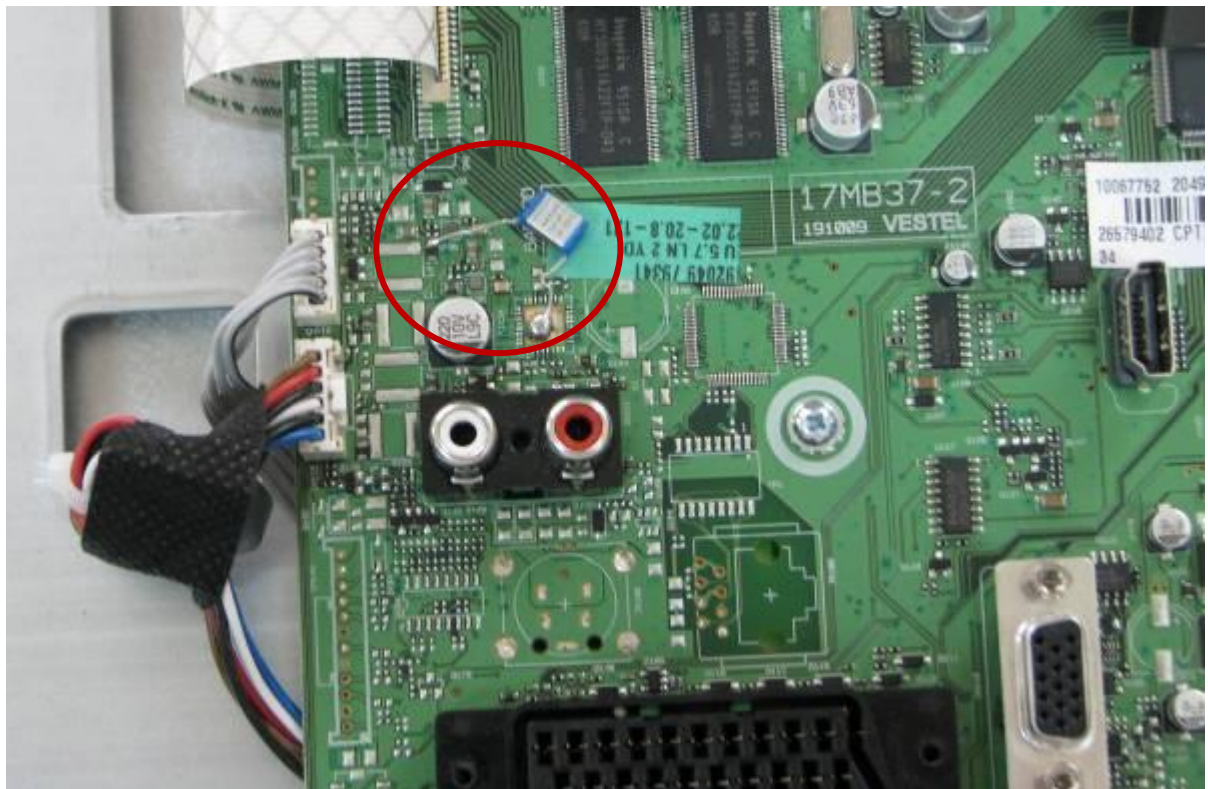
The TV emits a low volume high pitch noise from the left speaker.

Audio IC internal feedback fault.

Add 0.033uF (33nF) Polyester (Green cap) 63VAC 100VDC capacitor between SMD coil L4 and Ground as shown below.

Use double-sided sticky tape, or silicon glue to secure cap to the PCB.
