Notice

Category : <u>Multi-media Projector</u>	Issued Date : <u>May / 2009</u>
Model : <u>PLC-XF35NL</u> <u>PLCXF35N</u> <u>PLC-XF35</u>	Effective from : <u>Chassis No. MY8-XF3503</u>
Destination : <u>U.S.A.,Canada,</u> <u>Europe,Asia,Africa</u>	REF. NO. : <u>SM5110413</u>
	MY8-XF35NL03 MY8-XF35N03

Service Flash :
This service flash concerns the model replaced with new LCD Panel (LCX082BLF) by service. (Chassis No. is changed to MY8-XF3503, XF35N03, XF35NL03.)

REFERENCE NO. SM5110413-07

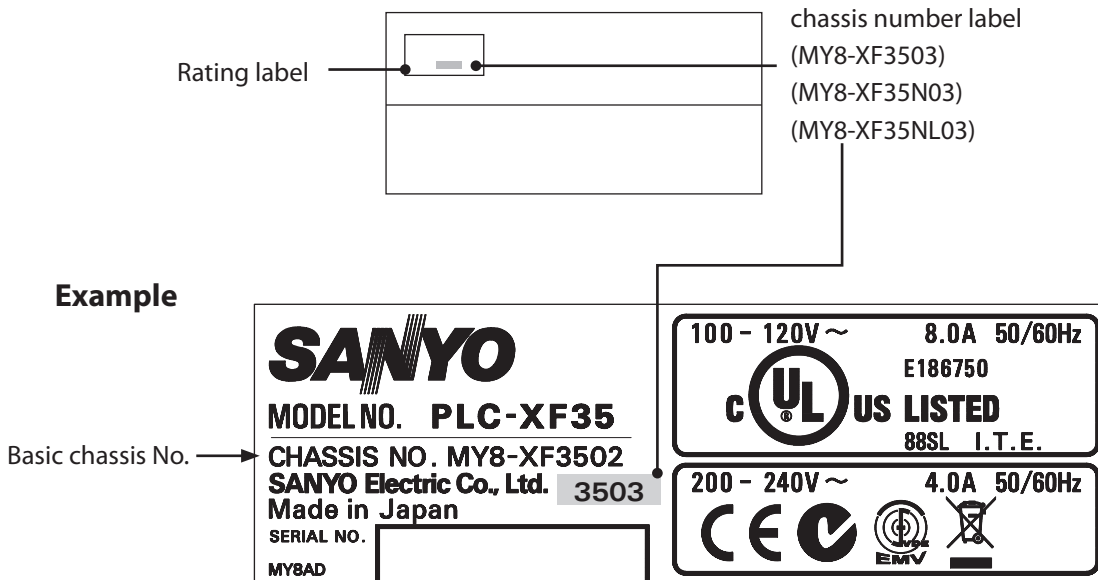
1. Chassis No. Check

Check the printed chassis number on the Rating Label.

This service flash is effective for the chassis number "MY8-XF3503, MY8-XF35N03, MY8-XF35NL03".

Two chassis No. is displayed.

The projector in which chassis No. of **MY8-XF3503, XF35NL03, XF35N03** is not displayed is off the subject of this notice.

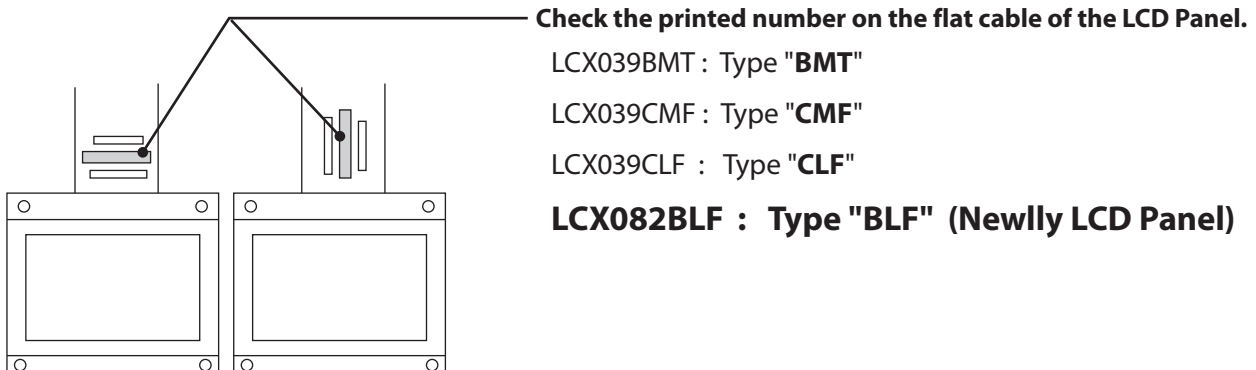
2. Panel Type Check

Check the printed number on the flat cable of the LCD Panel.

This service flash is effective for the type "BLF".
